Manhole Inspection Summary

Manhole # S41CC_042MH

Insp Date: 11/10/08 1:40 PM

Location Address: **1207 ashland av**

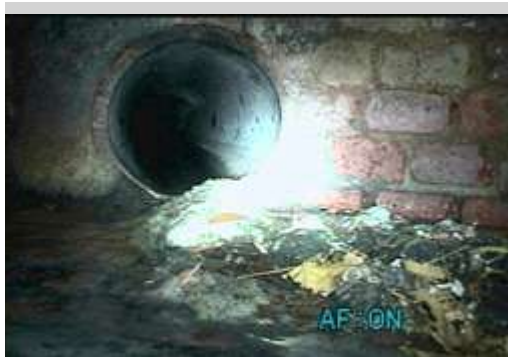
Defect 4

Condition: ☐ Sound ☐ Cracked ☐ Root Intrusion ☐ Deteriorated ☐ Leaks ☒ Debris

channel debris

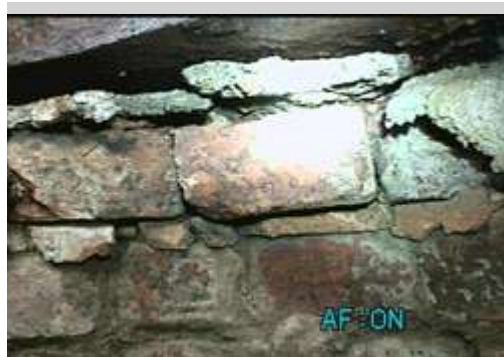
Defect 3

Condition: ☐ Sound ☐ Cracked ☐ Root Intrusion ☒ Loose Brick ☒ Deteriorated

chimney loose bricks deteriorated at frame joint

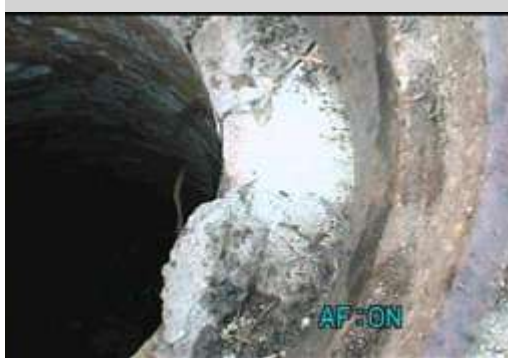
Defect 2

Offset: **5.5** (in.)

frame offset

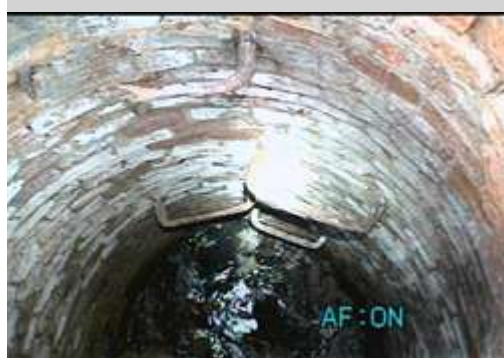
Defect 1

Count: **4** Missing: **0** ☒ Corroded

steps corroded

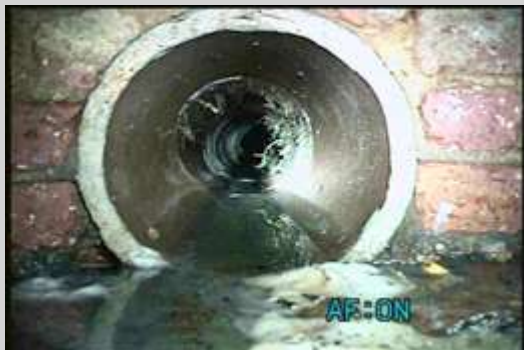
12 O'Clock Outflow

Infiltration: **None** Pipe Seal Cond: **Roots**
